# Roof Inspection Report

**1466 Madera Way, Millbrae**

Ernest ( Andy) Rodriguez  
June 2, 2010  
Report No. 142431

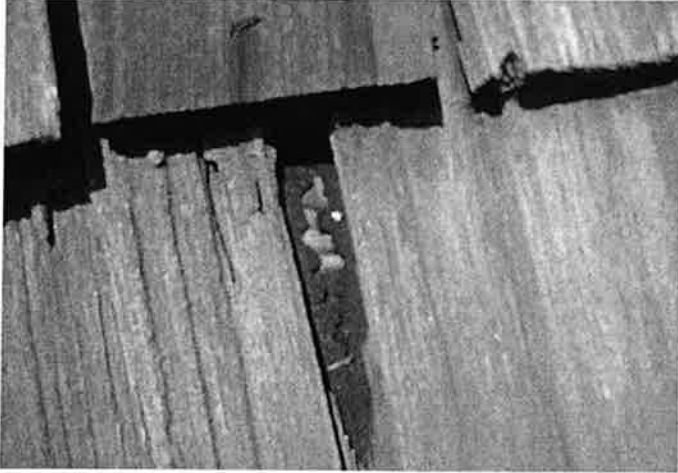
Picture 1

1. The felt underlayment is the primary method of waterproofing, if left exposed to the sun it will burn through allowing direct water entry into the structure. At the present time there are multiple areas of felt burn through. (See Picture 1) (See Picture 2) (See Picture 3) (See Picture 4) (See Picture 24) (See Picture 25)

Repair and/or replace all areas where the felt membrane has burned through.

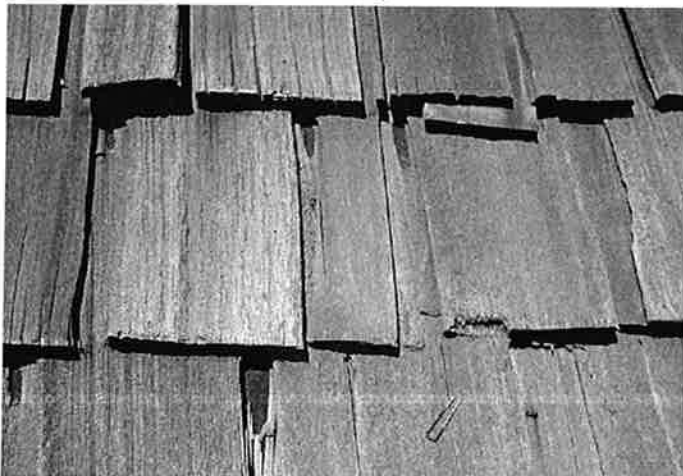
Picture 5

2. There are many areas where the felt underlayment is exposed to the weather, if left unattended the felt will burn through causing subsequent leakage. (See Picture 5) (See Picture 6) (See Picture 7) (See Picture 21) (See Picture 22) (See Picture 23) (See Picture 26) (See Picture 27)

Repair and/or replace all areas where the felt is exposed to the weather.
