Property Inspection Report

1466 Madera Way, Millbrae, CA 94030

Chris Kremer
Chris Kremer
June 2, 2010
Report No. 142431

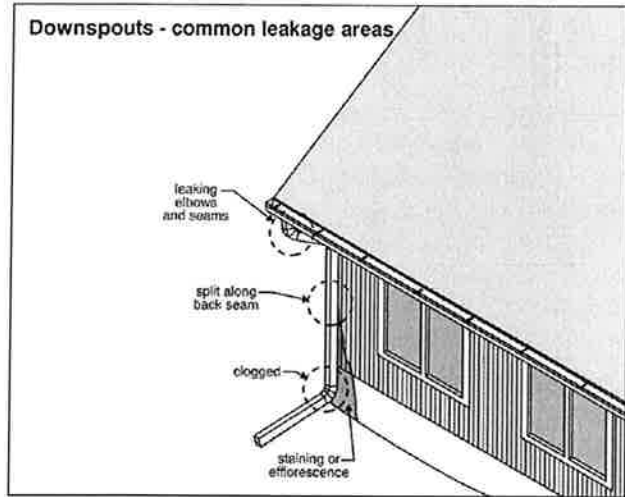
Illustration 4B

4. There were burnt through shakes on the roof. We recommend replacing the burnt through shakes to help extend the life of the roofing system.
5. The chimney was noted to move slightly when shaken. However, this amount of movement may be within acceptable limits. We recommend the chimney be further evaluated by a licensed masonry contractor.
6. Leaks were noted in the downspouts and/or gutters. During wet weather conditions these areas are more obvious and during dry weather conditions they are noted from the stains at the areas where the leaks have occurred. We recommend all leaks be repaired. (See Illustration 4B)
