WOOD DESTROYING PESTS AND ORGANISM INSPECTION REPORT

| Building No. 1466 | Street Madera Way | City Millbrae | ZIP 94030 | Date of Inspection 6/3/2010 | Number of Pages Page 1 of 7 |

HomeGuard Rpt #: **142431**

| General Description: This is a supplemental report to our report #0142431TPR, dated 6/2/10 and should be made a part there of. | Inspection Tag Posted: Garage |

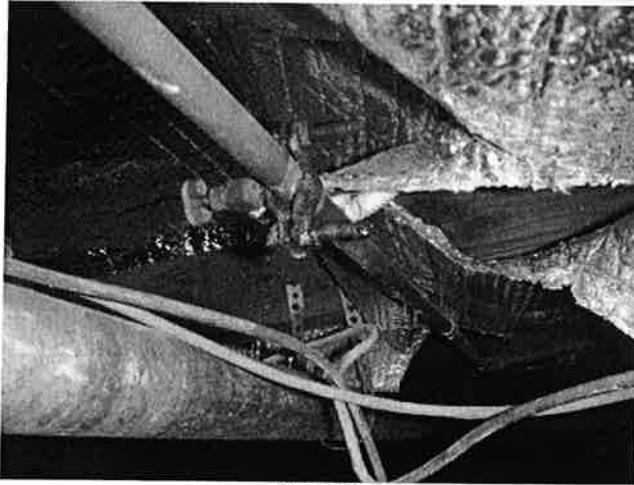
Picture 1

2G. FINDING: There is a plumbing leak at the kitchen refrigerator line in the subarea. (See Picture 1)

RECOMMENDATION: Reseal or repair this leak in the most practical way.
*******(SECTION 2 ITEM)*******

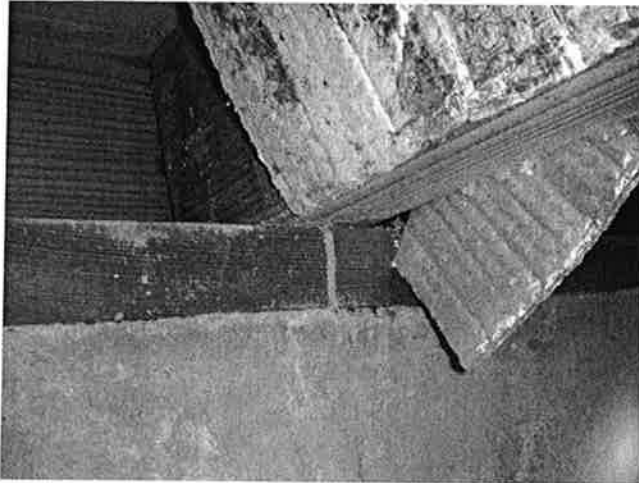
Picture 2

1M. FINDING: There is evidence of a Subterranean Termite infestation in the substructure area soil. (See Picture 2)

1N. FINDING: There is evidence of Subterranean Termite migratory tubes as noted in the above recommendation. (See Picture 2)

RECOMMENDATION: Treat the affected areas with Termidor SC(Fipronil:5-amino-1-(2,6-dichloro-4-(trifluoromethyl) phey)-4-((1,8,5)-trifluoromethyl)sulfinyl)-1-H-pyrazole-3-carbonitrile. **NOTE:** In order to perform this treatment the property will need to be vacated for the period during and 3 hours after the treatment is performed.
*******(SECTION 1 ITEM)*******

RECOMMENDATION: Break down & brush away all termite migratory tubes.
*******(SECTION 1 ITEM)*******

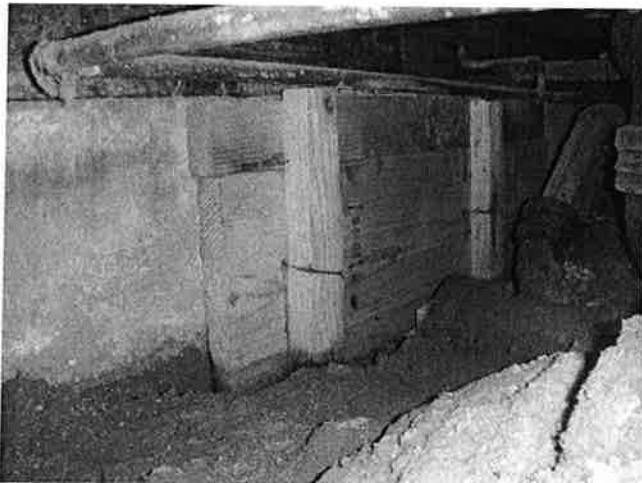
Picture 3

2F. FINDING: There are form boards in earth contact in the substructure area. (See Picture 3)

RECOMMENDATION: Remove as much of the form boards as practical and chemically treat the remainder with Termidor SC(Fipronil:5-amino-1-(2,6-dichloro-4-(trifluoromethyl) phey)-4-((1,8,5)-trifluoromethyl)sulfinyl)-1-H-pyrazole-3-carbonitrile.
*******(SECTION 2 ITEM)*******

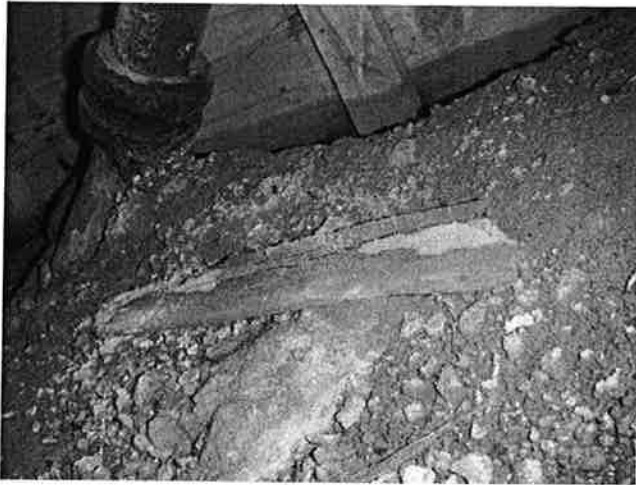
Picture 4

1P. FINDING: There is fungus infected cellulose debris in earth contact in the substructure area. (See Picture 4)

RECOMMENDATION: Remove the cellulose debris of a size that can be raked from the substructure area.
*******(SECTION 1 ITEM)*******

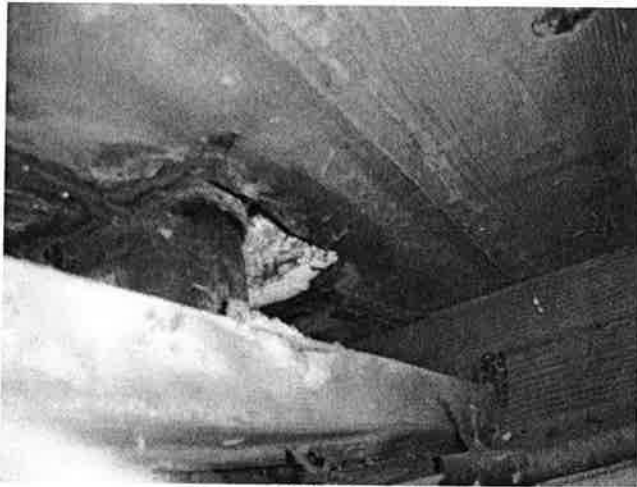
Picture 5

1O. FINDING: There is a surface fungus condition located under the master bathroom toilet and hall bathroom tub. (See Picture 5) (See Picture 7)

RECOMMENDATION: Scrape or wire brush this area and treat with a registered fungicide Timbor (Disodium Octoborate Tetrahydrate). **NOTE:** In order to perform this treatment the property will need to be vacated during and 3 hours after the treatment is performed.
*******(SECTION 1 ITEM)*******

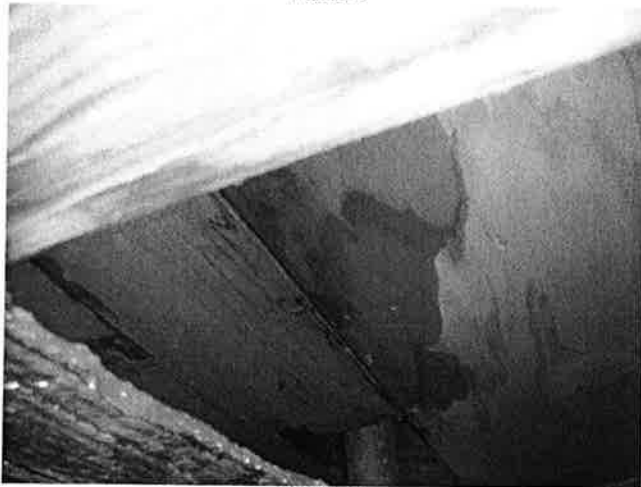
Picture 6

3C. FINDING: A standard water test was performed to the mortar shower in the master bathroom and leakage was evident below the shower. However, no visible fungus infections were noted under the master bathroom shower at this time. (See Picture 6)

RECOMMENDATION: Break out and remove the entire existing mortar shower to allow for further inspection. If no damages are found, install a new waterproof membrane. Install an entire new ceramic tile shower using an approved surface on the walls. We will do no wallpaper repairs in connection with this repair. If damage is found to extend into any inaccessible areas, a supplemental report and bids will be issued. Unless prior arrangements have been made, white tile will be installed. It should also be noted that all tile work regardless of color selection, would be done with a tight white grout joint.
