PROPERTY INSPECTION REPORT

BY THE HOMETEAM INSPECTION SERVICE
SERVING ALAMEDA, CONTRA COSTA, AND SAN FRANCISCO COUNTIES

Inspection Date: May 27, 2010

Address of Inspection: 321 Bloomfield Road, Burlingame, CA 94010

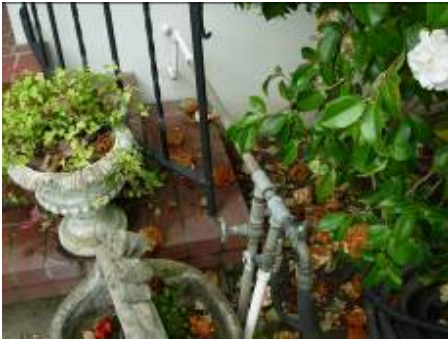
- A. The drain lines are an older cast iron system, parts of which have been replaced. A sewer camera inspection can help determine if these old drains are still functional. We recommend having such an inspection.
- B. The water piping at the front of the home was not supported. Recommend to secure. P-1

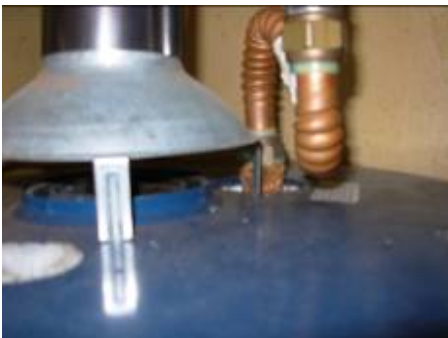
- A. There was corrosion observed at the water supply. Recommend to repair by a qualified licensed plumber. P-2
- B. There was no overflow pipe installed. Recommend to install.
