## WOOD DESTROYING PESTS AND ORGANISM INSPECTION REPORT

| Building No.<br><b>1466</b> | Street<br><b>Madera Way</b> | City<br><b>Millbrae</b> | ZIP<br><b>94030</b> | Date of Inspection<br><b>6/2/2010</b> | Number of Pages<br><b>Page 1 of 9</b> |

HomeGuard Rpt #: **142431**

| General Description: <b>One story, single family wood framed residence with brick and stucco exterior.</b> | Inspection Tag Posted: <b>Garage</b><br>Other Tags Posted: <b>None noted</b> |

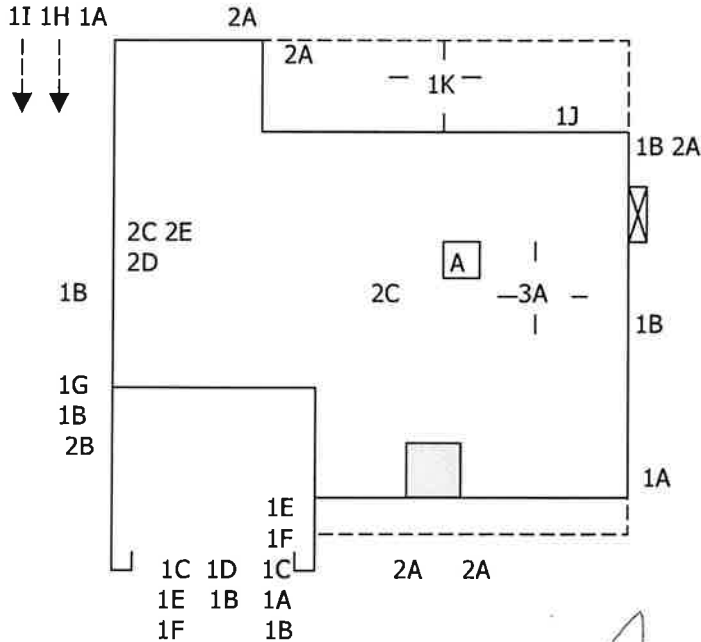
Key to Items on diagram: [1] Section 1 Items    [2] Section 2 Items    [3] Unknown Further Inspection Items

**FRONT**

Diagram Not To Scale

**1A. FINDING:** Fungus damage was noted to the barge rafter as indicated on the diagram. (See Picture 2)
